**ULTRASONIC VELOCITY MEASUREMENTS IN
CONCRETE, LOCK AND DAM NO. 24
MISSISSIPPI RIVER**

Henry T. Thornton, Jr., Dale Glass

Structures Laboratory

April 1980

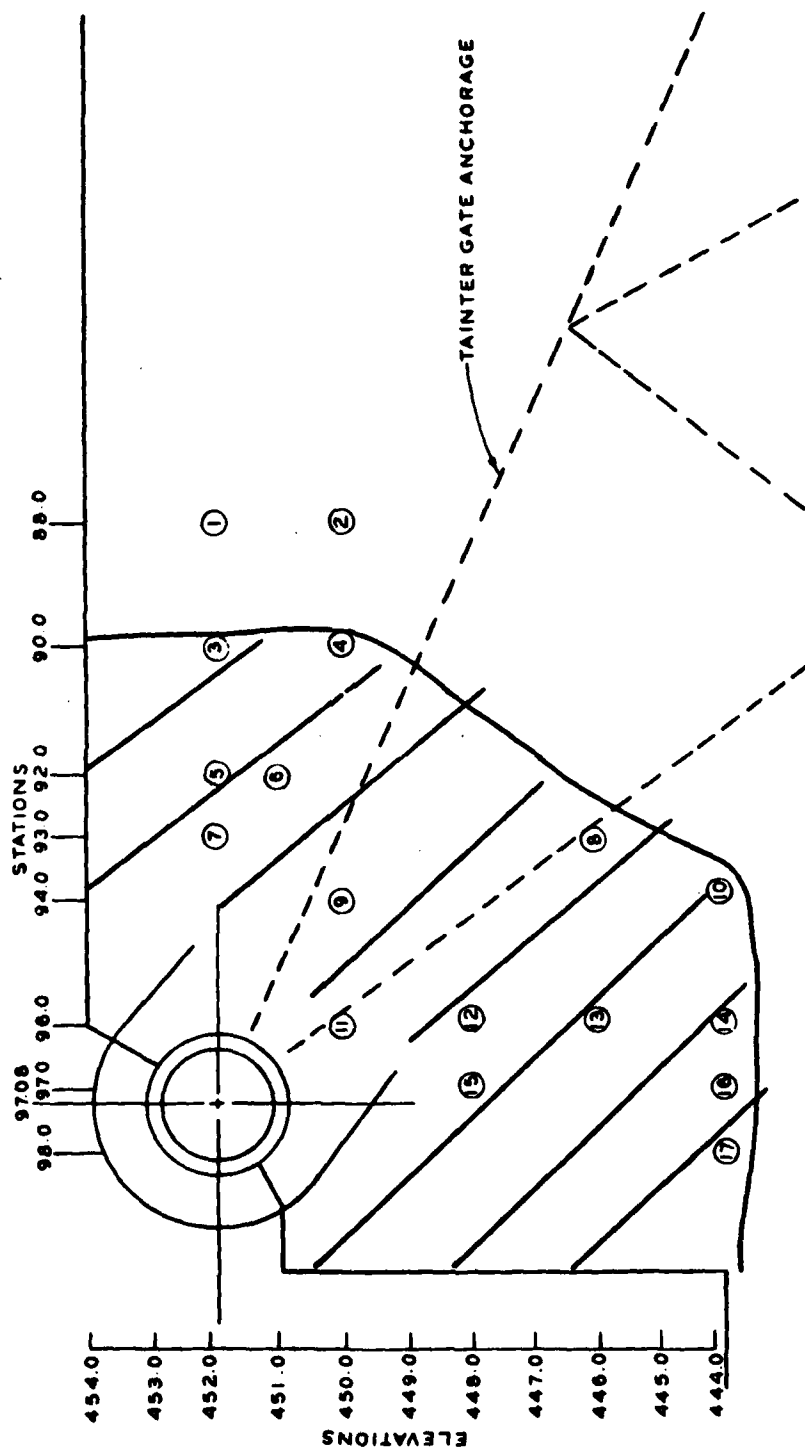
3. The test equipment used in this investigation is described in test Method CRD-C 51-72* (ASTM Designation C 597-71). Velocity measurements were made through piers No. 2 through 15 which constitute part of the dam structure. Access to both sides of a pier was gained by having the transducer holders move along the tainter gate arms located on each side of the pier. Also, a platform built by Lock and Dam No. 24 Government employees was lowered in place using the gantry crane in order to obtain access and make velocity measurements under the trunnion and near the waterline on each pier (Photo 2). The station numbers, elevations, path lengths, and velocities are given in Table 1. Figures 1 through 14 show the side elevations of each pier with the velocities obtained at each data point inscribed on the drawing. This was done in an attempt to delineate and compare areas characterized by low velocities (below 15,000 fps). Figure 15 outlines the area where anomalous velocities

were obtained. This area is bounded by the line of extreme cases, i.e., piers No. 4, 6, 9, and 13. The extremity of low or no velocity readings varies slightly with station number and elevation from pier to pier, but Figure 15 is generally representative of piers No. 2 through 15.

Figure 15. General area of indicated deterioration, Piers No. 2-15

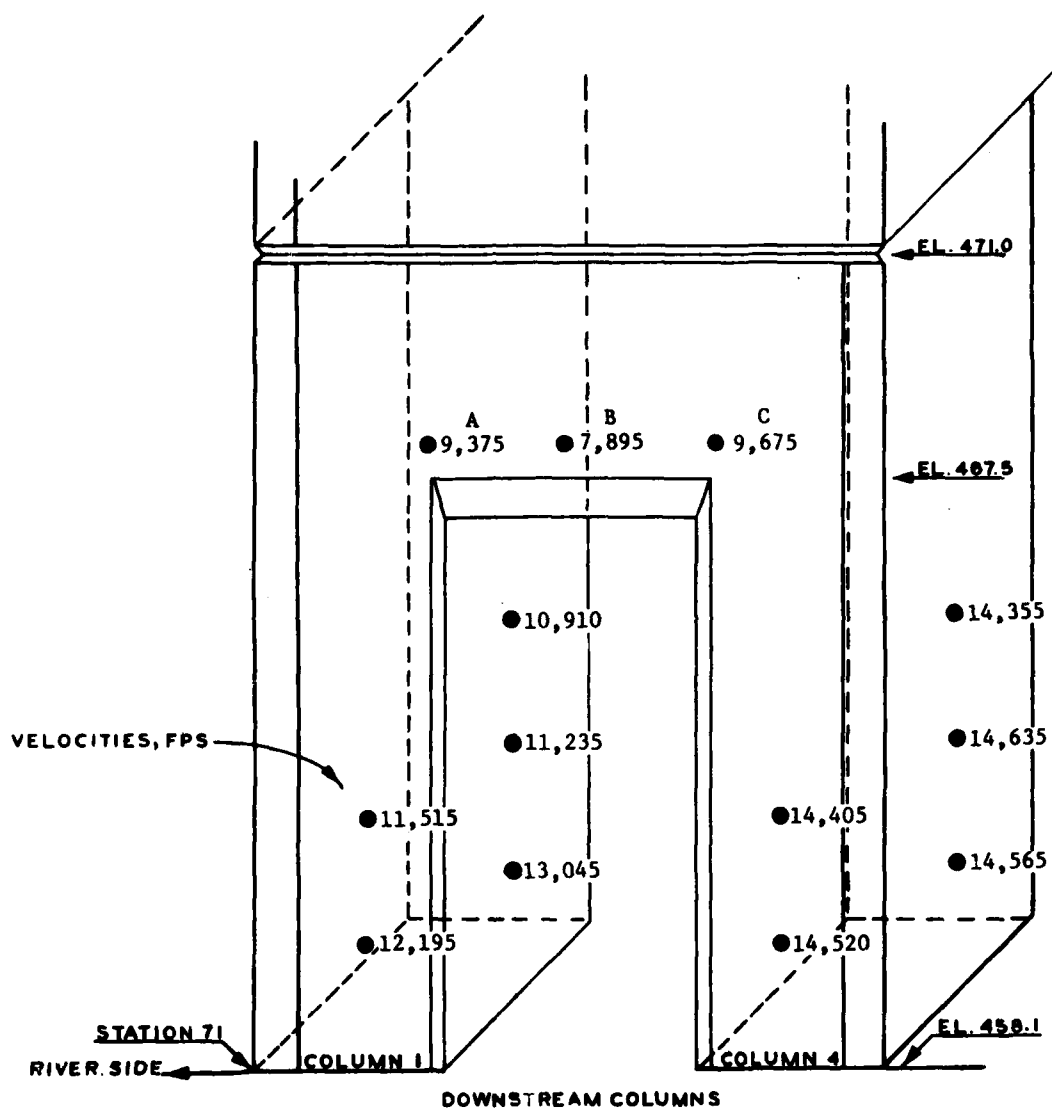
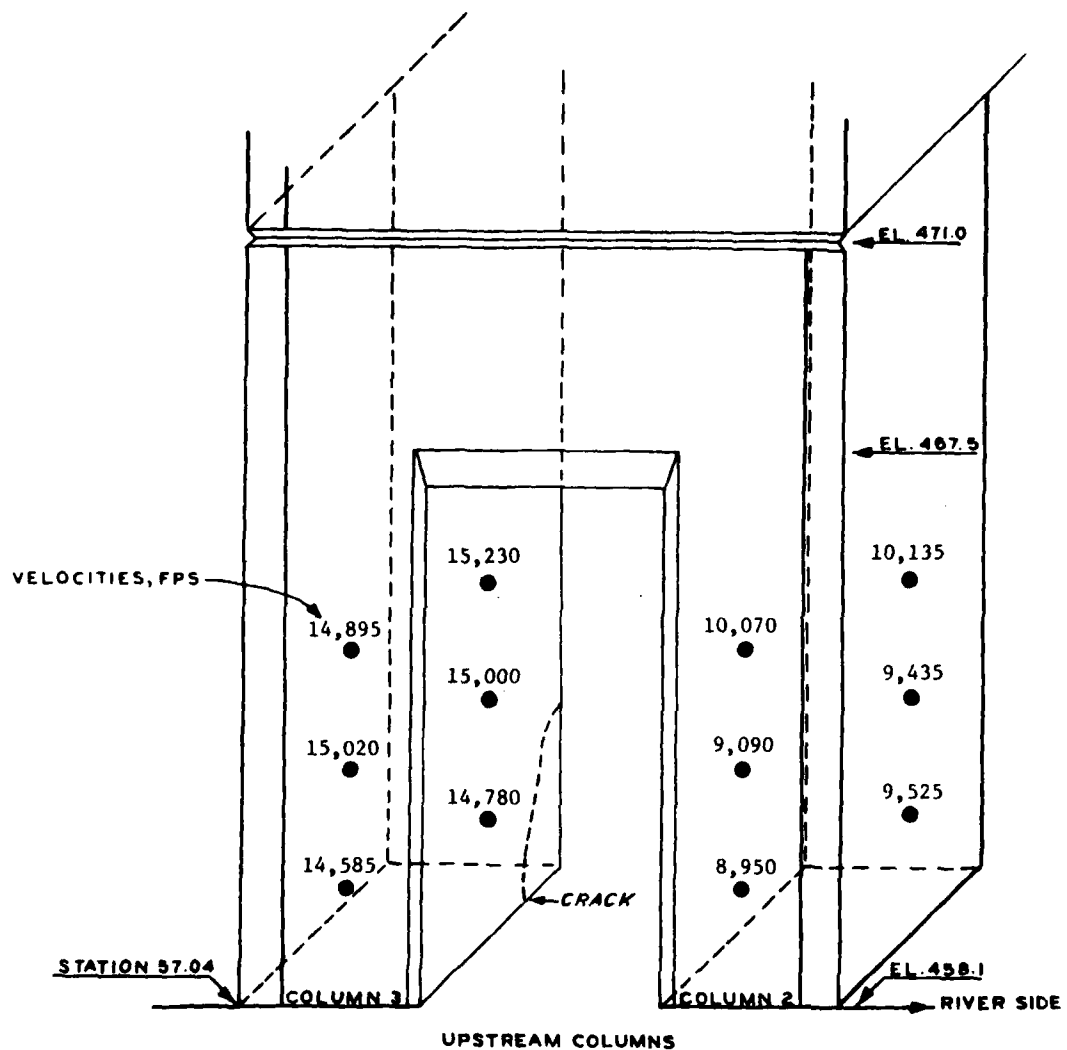
made through the lower elevations of the columns on pier No. 16. These measurements produced velocities in the 14,000- to 15,000-fps range, but there were also numerous velocities obtained in the range of 9,000 to 12,000 fps. These low velocities indicate the presence of cracks, some of which were visible, in the lower elevations of these columns.

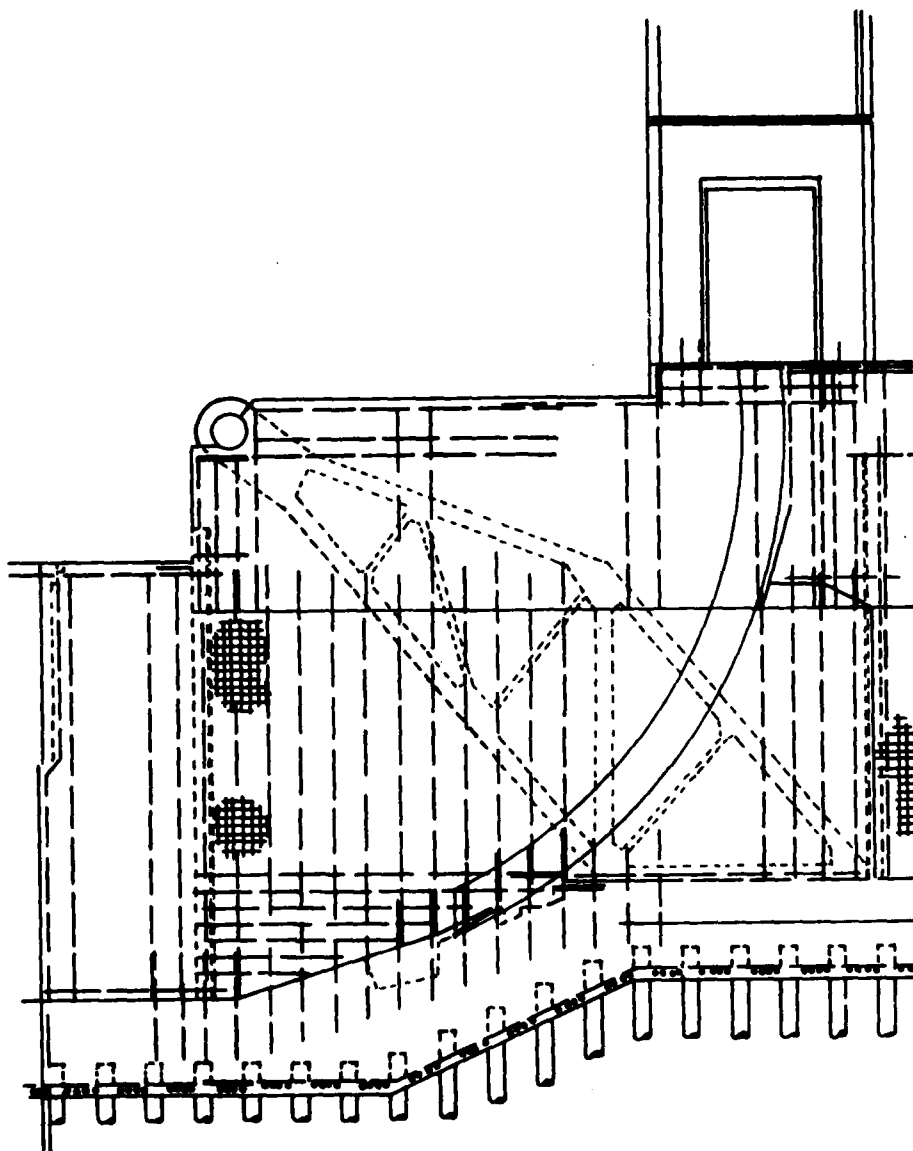
5. Figure 21 is a typical side elevation of piers No. 2 through 15, and shows the location of the embedded tainter gate tension anchorage. Figure 22 shows in more detail the upper portion of the anchorage and locates the velocity data points with respect to the anchorage beams. Data points 1 through 17 are of the current investigation. Data points A through D are of the 1973 investigation (mentioned in paragraph 3) that are thought to be pertinent here. Physical access to the downstream portions of the piers in the areas from which data were desired was restricted by the gate arms and the water level (Photos 1 and 2). The gates in each bay were manipulated to the allowable extent in order to maximize coverage of the extreme downstream area. In 1973 the gates were manipulated to expose maximum area between stations 79B and 90B at elevations 447 to 452. Although most of the data points used in the 1973 investigations were upstream from the data points used in the current study, four of them are pertinent to this study. Point A (1973) corresponds to point 4 (current); and points B, C, D (1973), although they do not correspond to current data points, have signal transmission paths that would pass through or near the steel anchorage beams. These four points, A, B, C, and D, are the only points of the 19 points used in 1973 that show decreased velocity; point B on pier No. 5 showed a decreased velocity; point C on piers No. 5 and 7 showed decreased velocities, and on pier No. 12 no signal passed through; at point D on pier No. 12 no signal would pass through. These data points located at or near elevations where the signal transmission path passed through or near the steel anchorage beam indicated the presence of some form of distress in 1973. The velocity data obtained in this current investigation tell the same story. There is some form of distress at or near the anchorage beams in the areas that were tested. A 12-in. steel beam normal to the transmission path in the center of a 10-ft section of concrete, if it were bonded, would not appreciably affect the ultrasonic velocity. Even an unbonded condition should not cause a drastic reduction in velocity. The data indicate that a general condition of cracking

Figure 21. Typical pier elevation showing location of tainter gate tension anchorage

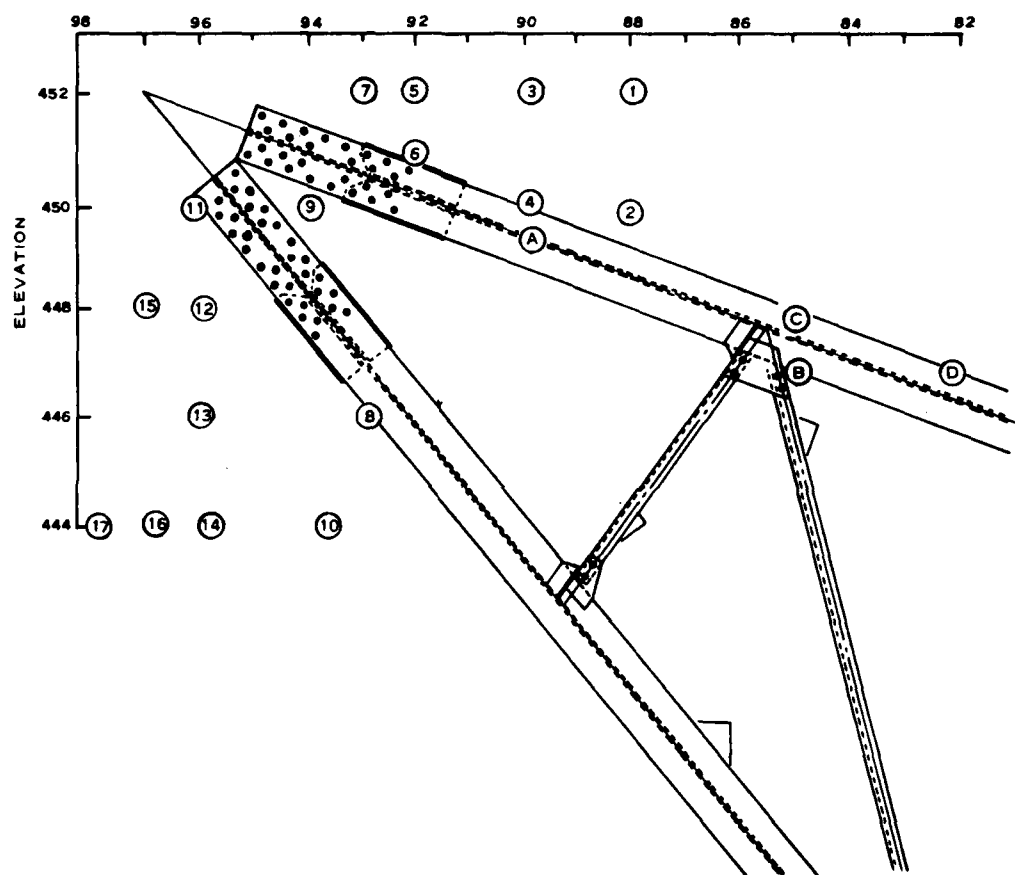
and deterioration existed around and near the trunnion, head plates, and anchorage beam connections in each of the piers tested, and that some cracking has probably occurred around the top anchorage beam as far down as 15 ft from the trunnion and around the lower beam as far as 6 ft from the trunnion in some piers.

Figure 22. Location of velocity data points with respect to embedded tension anchorage beams

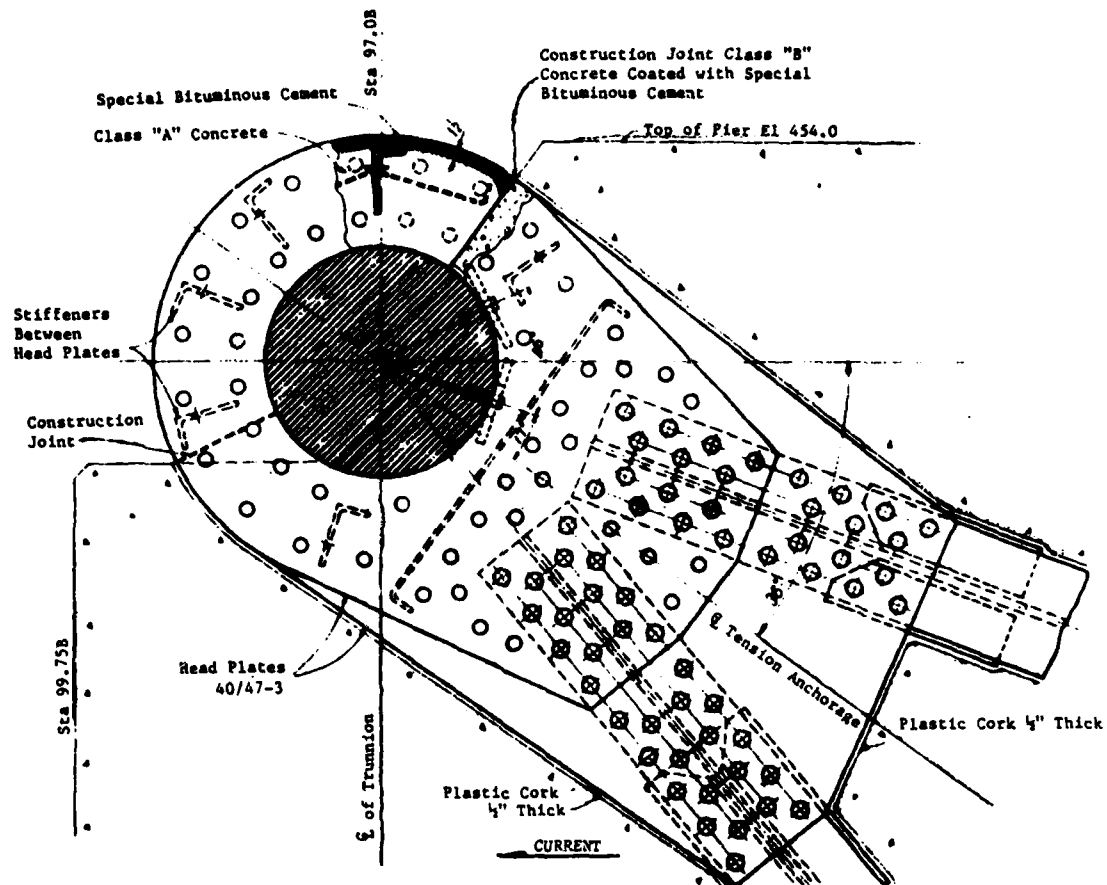
6. Figure 23 is a typical detail drawing of the trunnion, head plates, and anchorage beam connections. This drawing shows a 1/2-in.-thick plastic cork covering most of the head plates and extending down the anchorage beams for some distance. Also shown is a bituminous cement in the construction joint. The deterioration over the years of this cement or cork, or both, could provide a path for water to enter between the concrete and steel anchorage beams. The V-shaped depression at the junction of the concrete and trunnion head plate provides a reservoir where water could be stored for short durations. Stress concentrations at and near the trunnion and anchorage beam connections caused by vibrations of the gates could have provided the mechanism by which small cracks were formed and also could have added to the water intake. Periodic gate vibrations of a severe nature have been described by lock personnel and confirmed by members of the District office. Progressive cracking due to stresses from vibration, and the possible contribution of freezing and thawing of the water, and alkali-aggregate reaction could have resulted in the present condition of the piers. A similar combination of mechanisms probably caused the similar condition of the upper portion of the columns, i.e., cracks caused by stresses from vibration or structural movement and water entrance, with the floor slab at elevation 471.0 serving as a pooling area. Some of the larger cracks in the columns appear to have been caused by static stresses. Although it is beyond the intended scope of this investigation and report to address this issue, one or two observations will be offered here. The movement of a pier, of sufficient magnitude, could place any or all columns on that pier in a condition of inordinate static loading. It has been shown in the laboratory that the resistance to lateral movement (sliding) of a massive structure is greatly reduced while in a state of dynamic excitation, i.e., vibrating motion. The lateral force required to move a 3-

Figure 23. Detail of trunnion, head plates, and anchorage beam connections
